DEPARTMENT OF TRANSPORTATION**DIVISION OF ENGINEERING SERVICES**

Office of Structural Materials

Quality Assurance and Source Inspection

Contract #: 04-0120F4Cty: SF/ALA Rte: 80 PM: 13.2/13.9File #: 69.15**SOURCE INSPECTION REPORT****Resident Engineer:**Siegenthaler, Peter**Address:** 333 Burma Road**City:** Oakland, CA 94607**Report No:** SIR-002889**Date Inspected:** 16-Jan-2011**Project Name:** SAS Superstructure**OSM Arrival Time:** 1500**Prime Contractor:** American Bridge/Fluor Enterprises, a JV**OSM Departure Time:** 300**Contractor:** Zhenhua Port Machinery Company, Ltd (ZPMC), Changxing Island **Location:** Shanghai, China**Quality Control Contact:** Mr. Don Walton**Quality Control Present:** Yes No**Material transfer:** Yes No N/A**Sampled Items:** Yes No N/A**Stock Transfer:** Yes No N/A**OK to Cut:** Yes No N/A**Rebar Test Witness:** Yes No N/A**Delayed/Cancelled:** Yes No N/A**Other:** Coating Inspection**Bridge No:** 34-0006**Component:** See Below**Bid Item:** 77, 78, 79**Lot No:** B #204**Summary of Items Observed:**

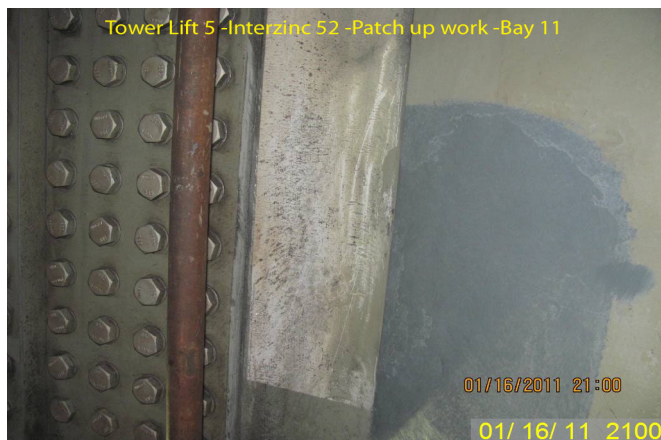
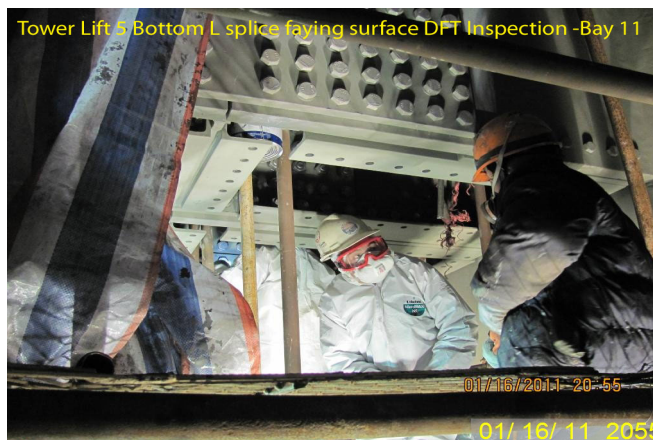
An inspection was requested on the Tower Roll cage -3 nos, Roll cage splice -10 nos, Service platform Hand rail -15 pieces and Ladder -4 nos , vide inspection request no. T -1943 for Surface preparation inspection at Painting shop 2. This QA inspector observed, ABF Inspector Ms. Helen found inspecting these surfaces . This was found accepted by ABF Inspector after minor touch ups. Ambient conditions found measured by ZPMC QC Inspectors 13.2 deg. celcius above dew point and the relative humidity found to be 32.3 % which is acceptable as per contract documents. International protective coatings technical service representative Mr. Li Peng was found present during the course of this inspection process for Technical discussion.

An inspection was requested on the Tower, Lift 5 Grillage shaft -4 nos, Internal surfaces and Bottom Faying surface, vide inspection request no. T -1945 for DFT check after Interzinc 22 application. This QA inspector observed, ABF Inspector Mr. Sun and Mr. Wei found inspecting these surfaces . This was found not accepted by ABF Inspectors for Holidays and Runs. Interzinc 52 patch up works found where Lifting lugs have been removed which was more than 150 x 150 mm accepted by Contract documents for patch works. International protective coatings technical service representative Mr. Andy was found present during the course of this inspection process.
